**ZOOM, 29<sup>th</sup> of April 2021**

**Continental Disc® Corporation**

**Philip Fedosenkov & Dennis van den Brink**

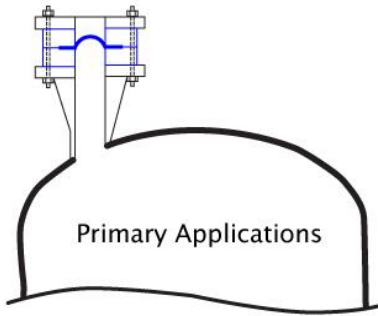
Primary  
Relief

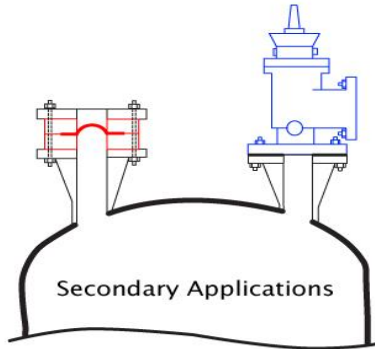
Secondary  
Relief

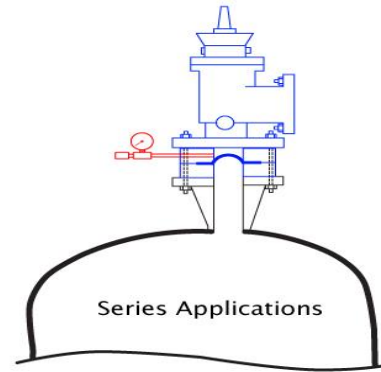
Series  
Relief

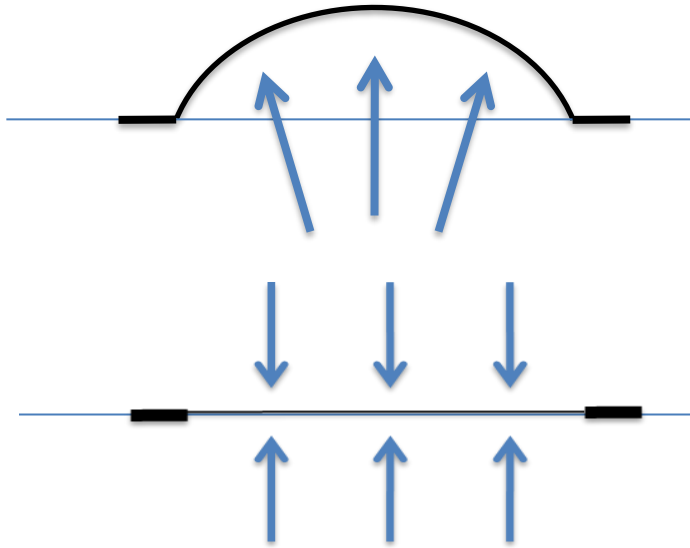
- Forward Acting
- Also known as Tension Type
- Typically limited to static service
- Susceptible to fatigue in cyclic service

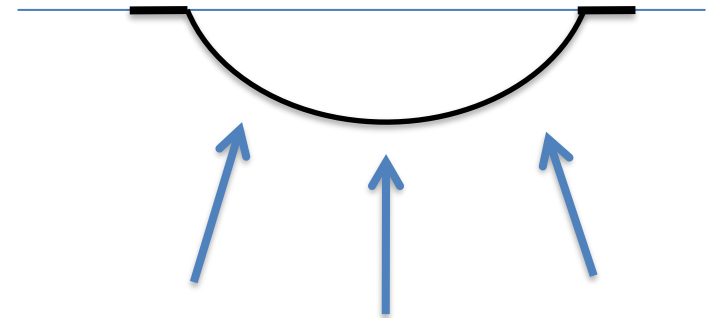
- Reverse acting
- Precise performance
- Highly resistant to fatigue in cyclic service
- Superior maximum working pressure ratio

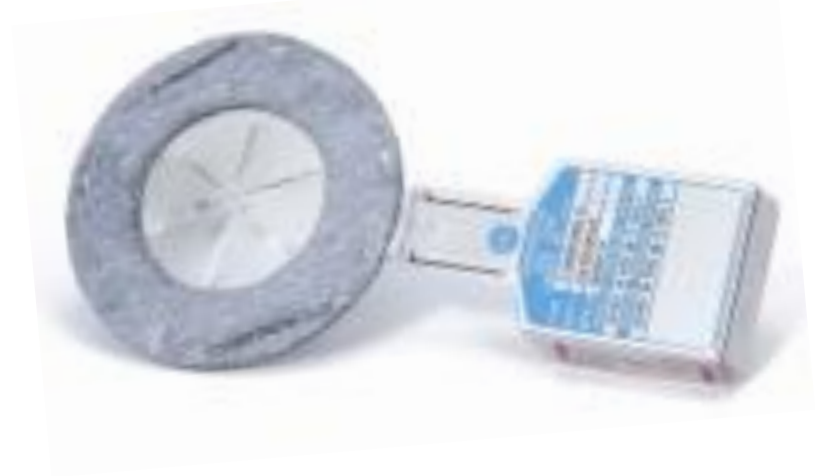
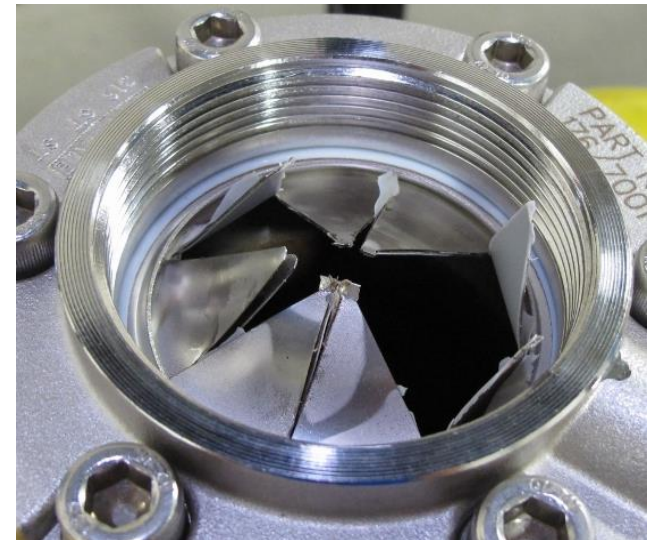
# Rupture Disc Design Flat Forward acting

- Oldest disc technology still used sometimes for very low pressure applications
- Prone to fatigue failures due to flexing
- Poor maximum working pressure ratio (typically 40 – 50%)
- Reduced flow characteristics

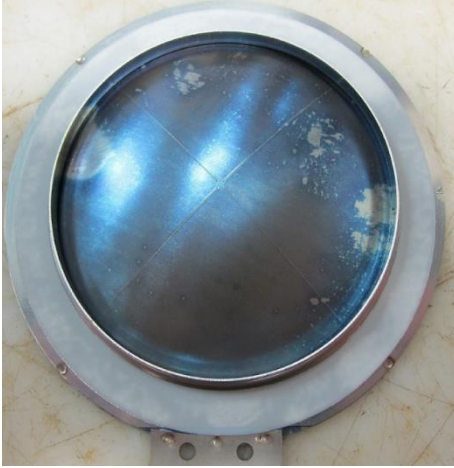
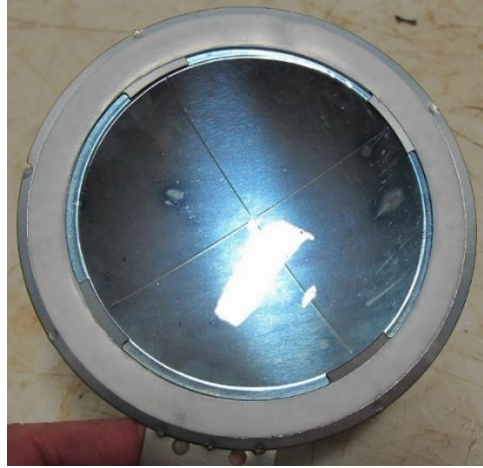
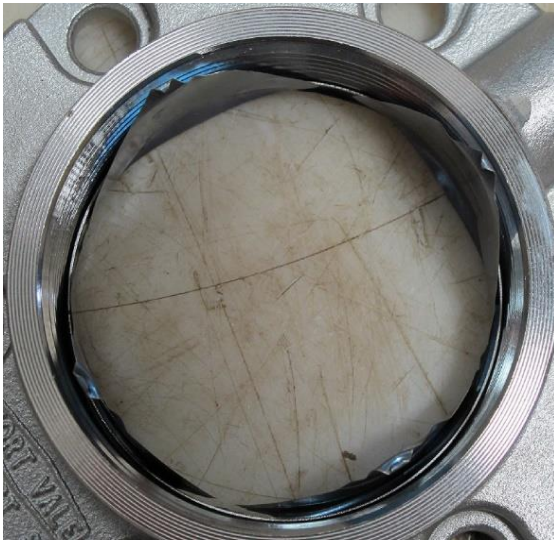
# Rupture Disc Design Domed Forward acting

- **Most commonly used design for ITC applications**
- **Domed to mitigate the affect from flexing**
- **Superior flow compared to flat designs**
- **Increased flow capacity designs are available**

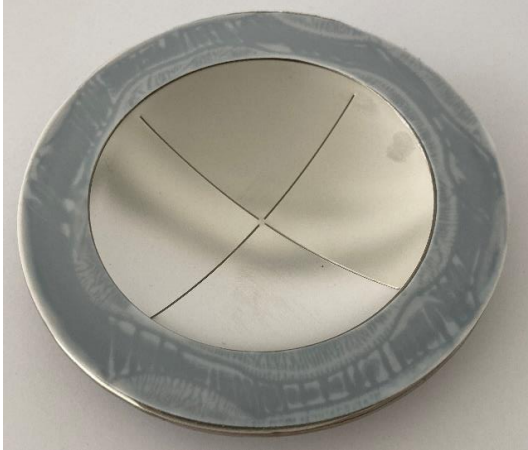
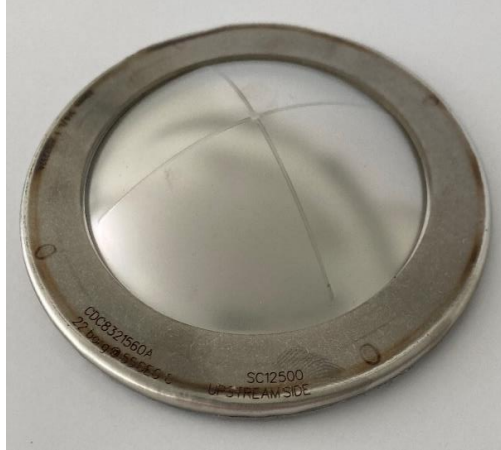
# Rupture Disc Design Domed Reverse acting

- Mostly used for Gas tank containers
- Excellent fatigue resistance
- Leak-tight design

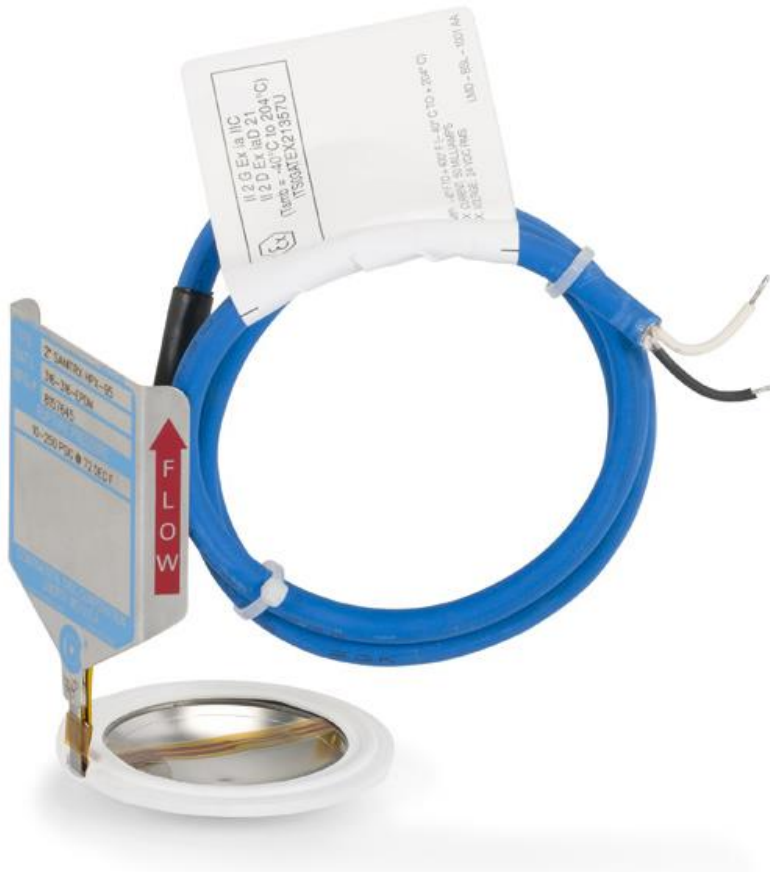
- Integral BDI

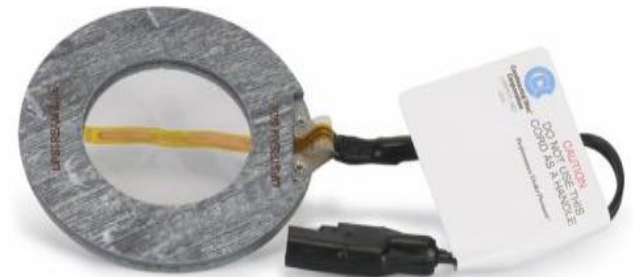
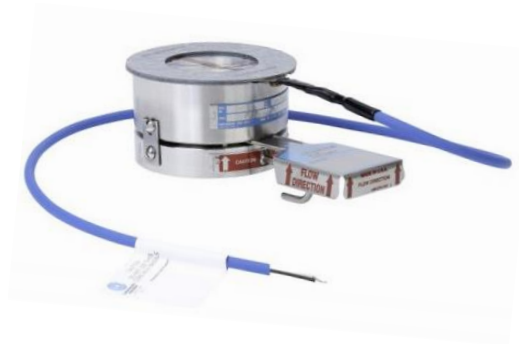
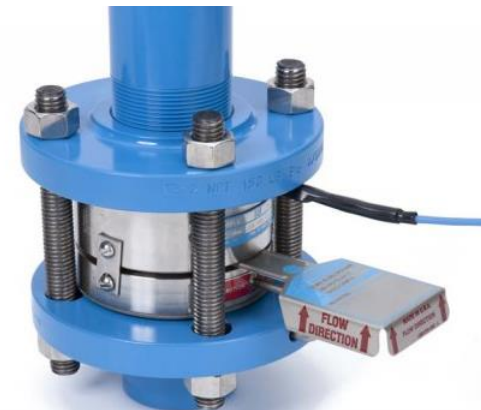
- Separate BDI
