Acceptable Container
Condition.

**International Tank Container
Organisation.**

ITCO ACC Edition September 2017 ©

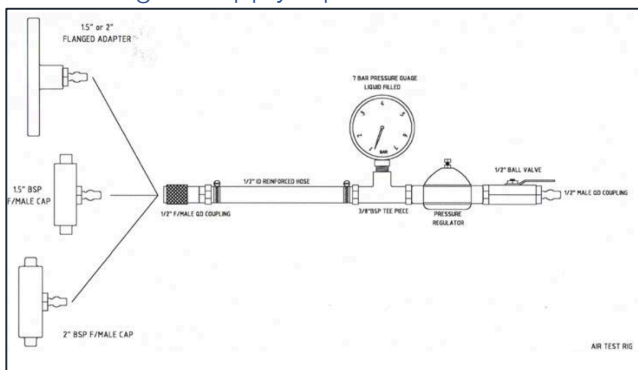
Air Test Rig

Connecting air supply top tank
